# SERVICE BULLETINS

RE.	PRODUCT
GEARBOX	P
M 30, M 40	GROUP
	43
DATE	NO.
15th June 1962	1

## Concerning shrill noise from the synchronizing cones.

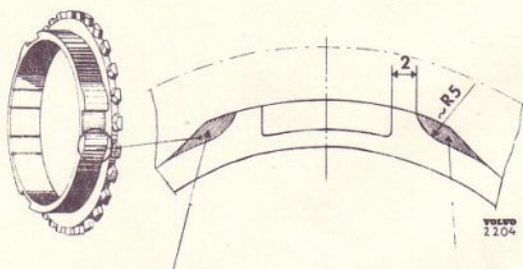
Cases have occurred on the above-mentioned gearboxes of a shrill and piecing noise arising as a result of a vibrating synchronizing cone. In order to remedy this, it may be necessary to introduce unbalance to the cone which vibrates. This is done by removing material from both sides of one groove as shown in the figure.

Shaded portion removed

1. If the noise occurs when driving in 1st or 2nd speed, it is generally the 3rd or 4th speed cone which vibrates.
2. Noise occurring when driving in 3rd or 4th speed usually comes from the 1st or 2nd speed cone.
3. On a cone that vibrates, greater wear occurs at the groove edges after driving for a relatively short time than on a cone that does not vibrate.
