SERVICE BULLETIN

| RE: | THROTTLE MECHANISM NOISE | PRODUCT | P |
| | B 20 B, -E, -F | GROUP | 27 |
| DATE | August 28, 1973 | NO. | 5 |

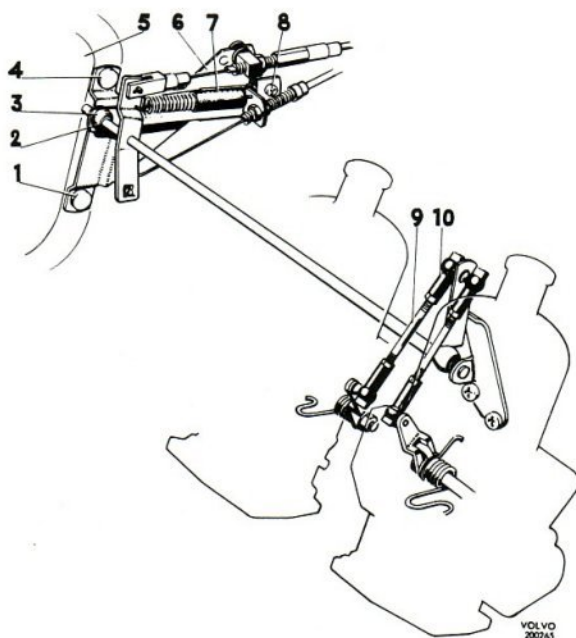
Throttle linkage (carburetor engines and automatic transmission)

Following alterations have been introduced on the production line in order to prevent noise from the throttle.

The throttle mechanism has been provided with plastic ball joints, plastic bushing for bracket and a new type bracket. The return spring has in B20 B been provided with a rubber cover (pos. 7 in the sketch).

1973 models with noisy throttle linkages can be remedied by installing following parts:
