# SERVICE BULLETIN

RE.	HOT START VALVE SU-HIF6 CAR- BURETTORS	PRODUCT P
	B 20 D, B 20 B	GROUP 23
DATE	4th January, 1972	NO. 8

## Incorrectly adjusted hot start valves

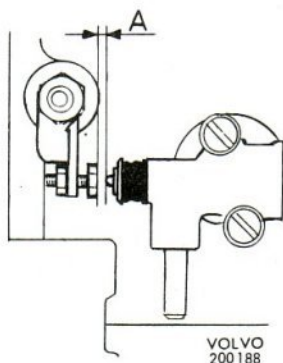
In connection with the introduction of rubber bellows on the hot start valves (see SB - P - 23 - 7), a number of valves have been incorrectly adjusted in production.

If you get complaints about poor hot start valves in vehicles with these chassis numbers, check first to make sure that the hot start valves are properly adjusted.

With the throttle in the idle position, measurement A between the control rod and the adjusting screw (see Fig.) should be max. 1.0 mm (0.039"), when the control rod is pressed to its bottom position.
