VOLVO

SERVICE BULLETIN

RE:	PRODUCT
CAMSHAFT	BLP
	GROUP
	21
	NO.
DATE	10
19 June, 1967

Camshaft damage

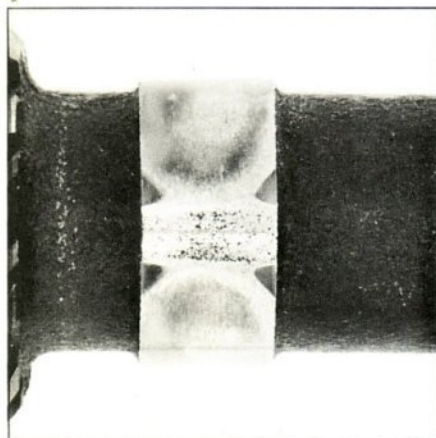
VOLVO
200 083

It has also been shown that the different grades of oil provide different patterns, but what is important in this connection is that such cams are not worn down. One explanation for this can be that the small pittings can serve as oil cavities and thus provide the contact surfaces between the cam and the valve tappet with suitable lubrication.

Figures 1 a - b and 2 a - b show two different cams with different pitting patterns, both of which can be considered as acceptable from an operational point of view.

Fig. 1 a. Clearly seen pitting pattern

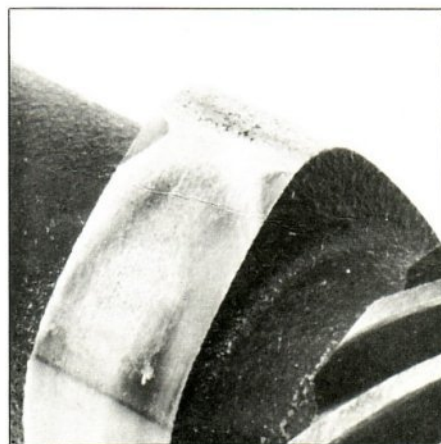
VOLVO
200 084

Fig. 1 b. Clearly seen pitting pattern
