SERVICE BULLETIN

RE:	AUTOMATIC TRANSMISSION BW 35	PRODUCT P GROUP 44 NO. 1
DATE	October 25, 1972

Valve spindle for centrifugal governor

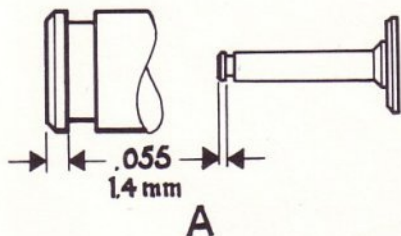
It has happened on a number of occasions that the valve spindle for the new centrifugal governor, see WB P - 44 - 26, has been too long. With unfavourable tolerances, the spindle can catch in the inside of the rear housing and disturb the function of the governor.

A. Correct spindle

B. Incorrect spindle

When fitting a new governor, or when checking an installed governor, check also the measurement according to the Figs. below. If the spindle is too long (B), grind it off to the correct length (A).
