hydraulic servo units

The Mk 2A Hydraulic Servo unit and Powerstop has been completely superseded by the Mk 2B unit. To save space therefore this manual page does not describe and illustrate how the unit works, but does provide the necessary Servicing, Testing and Fault Finding information.

This manual page deals with the Mk 11B Hydraulic Servo Unit and Powerstop, which superseded the Mk 11A. The external differences between the two units can be seen from the illustration (Fig. 1). Internally the basic design is unchanged but small improvements have been made and these are (1) operational 'clonk' has been eliminated by the anti-knock output piston, (2) the vacuum piston has been replaced by a diaphragm and; (3) the vacuum connection is now in the vacuum chamber and not the hydraulic body. The design of the vacuum chamber and the retaining band, which holds the two halves of the shell together, makes the outside shape slightly different but, with few exceptions it is expected the Mk 11B unit will eventually replace the Mk 11A in service.

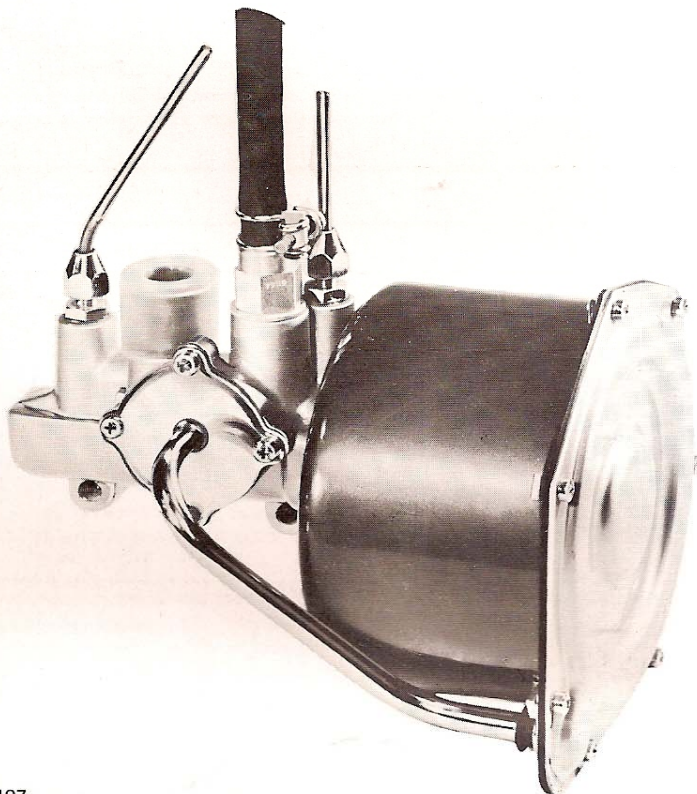
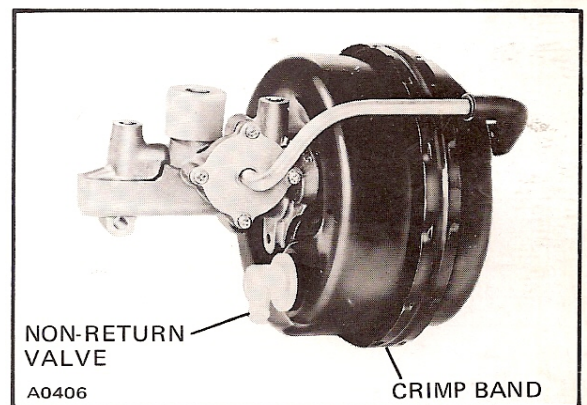
1 MK 2A SERVO UNIT

When replacing a Mk 2A unit with a Mk 2B unit, as the illustration shows, the two units are slightly different in shape and therefore minor modifications may be necessary on some installations. The changes fall into two categories:-

The vacuum hose connection on Mk 2B units is in the vacuum shell and not, as with Mk 2A in the hydraulic body. It is therefore expected that the vacuum hose will need to be longer. A longer length of hose than the one originally fitted should therefore be obtained from your Girling distributor.

Because the crimp band makes the Mk 2B unit slightly bigger overall, modifications may be necessary on some installations. In some cases, the fitting of spacers between the unit and brackets, would make alterations to the brackets unnecessary.

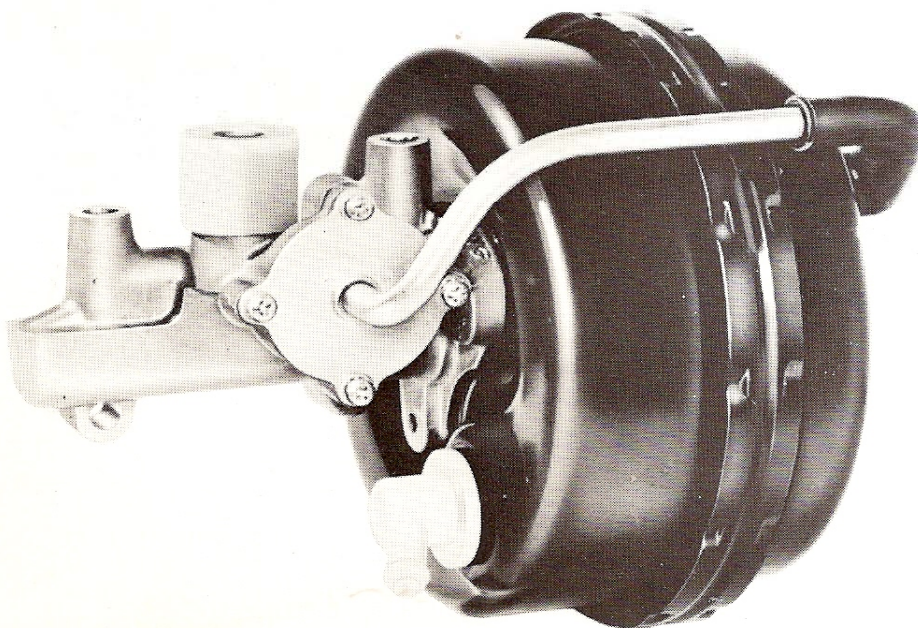
1

MK IIA SERVO UNIT

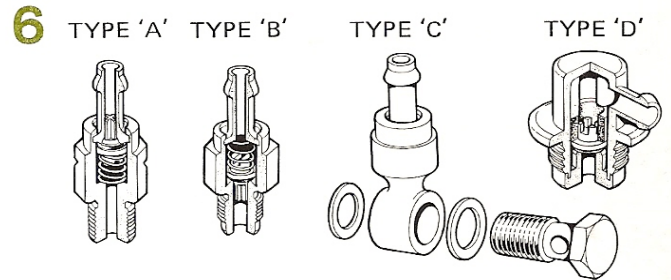
in the tank or servo unit so that power operation of the brakes is possible for a limited period, should a vacuum failure occur. Fig. 6 shows the types of non-return valves in use: Type 'A' screws directly into the engine manifold; Types 'B' and 'C' are usually fitted in the servo body of Mk 11A units; and Type 'D' which is a push fit in the rear shell of the unit and may have a straight or right angled nozzle. Type 'D' is white in colour so that it can be distinguished from the slave adaptor coloured red. If a red slave adaptor is fitted in the rear shell instead of a white type 'D' non-return valve, a non-return valve must be fitted at some other point in the vacuum line.

Type 'A' works in the opposite way to types 'B', 'C' and 'D' as the half ball, or plate valve, is in the opposite end of the valve body. The illustration shows the arrangement of the internal parts of types 'A' and 'B', and also shows the 'V' cuts in the hexagon body which identify type 'A'.

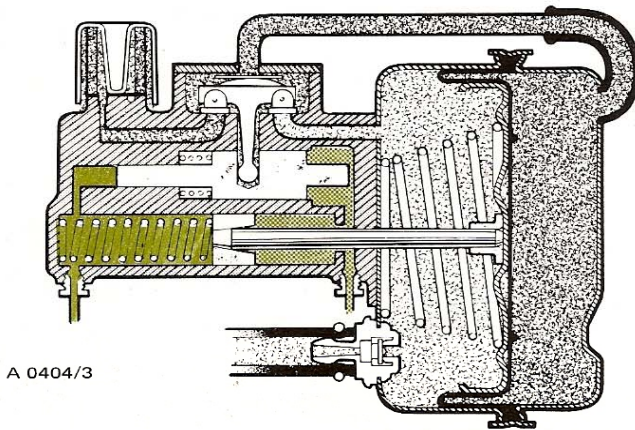
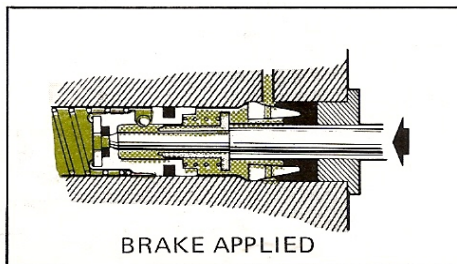
4 BRAKE HELD ON

If the force on the pedal is increased after arriving at the position shown on Fig. 4, the valve gear operates to give additional assistance from the diaphragm until the thrust on each end of the control piston is balanced or until the limit of available vacuum is reached. Conversely, if the foot pedal force is reduced the valve gear operates to reduce the pressure at the brake cylinders until again, a state of balance of the control piston is reached. The difference in area between the two opposed ends of the control piston determines the proportion of assistance provided by the unit. If, for example, the large end is twice the area of the small end, the hydraulic pressure output is built up to twice that of the input from the master cylinder before the control piston moves back to close the air valve. Such a unit therefore would have an output of twice the pressure of the input, throughout the range of the unit.

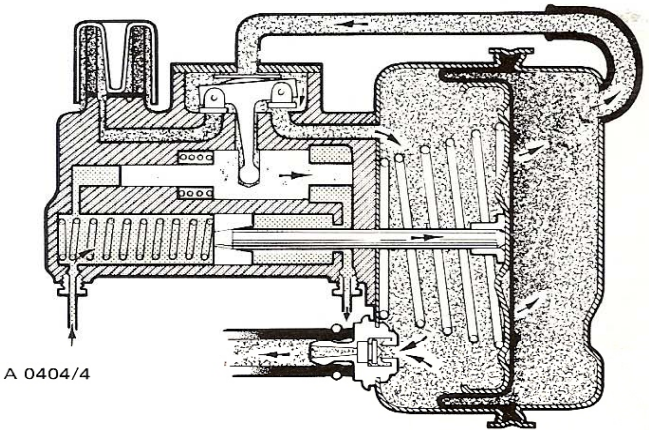
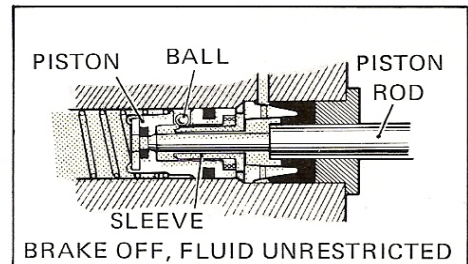
5 BRAKE RELEASED

returns and with it the output piston, relieving the pressure to the wheel cylinders as shown on Fig. 5. The piston sleeve lifts the ball and allows the fluid to move unrestricted between the supply tank and wheel cylinders.

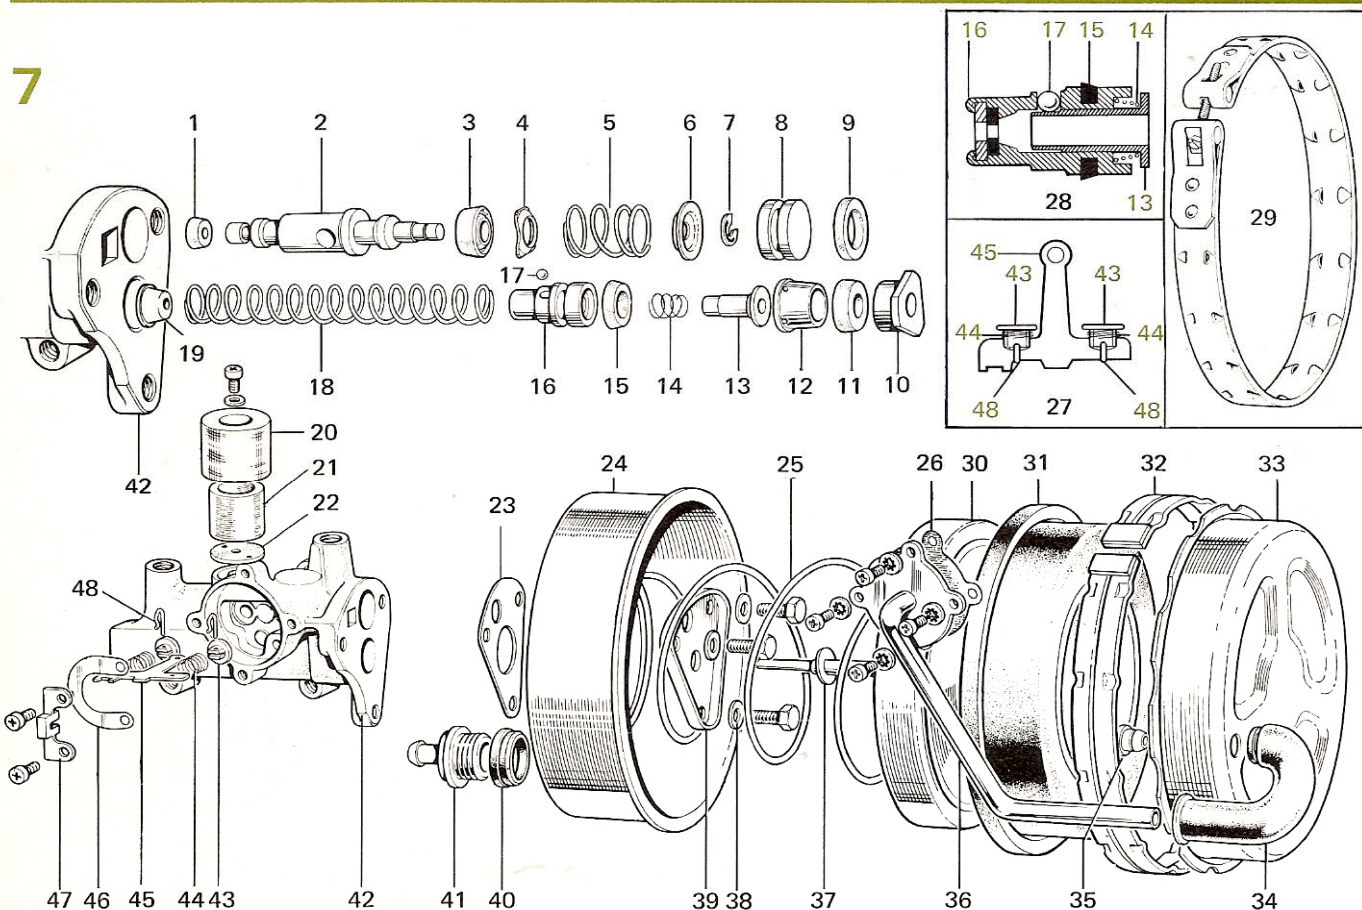
7

Listed below are the kits available to service the unit; the relevant parts contained in each kit can be seen on the illustration (Fig. 7).

MAJOR OVERHAUL KIT

- Rubber Sleeve
- Plug
- Diaphragm
- Body Gasket
- Copper Washers (three)
- Plug Seal
- Control Piston Seal (primary)
- Control Piston Seal (secondary)

- Piston Rod Gland Seal
- Output Piston Seal
- Output Piston Assembly
- Clamping Ring
- Valve Chest Cover Gasket
- Grommet (non-return valve)
- Girling Grease No. 64949009

FILTER KIT

- Filter Element
- Filter Base Washer

NON-RETURN VALVE KIT

- Non-return Valve
- Grommet
- Girling Grease No. 64949009.

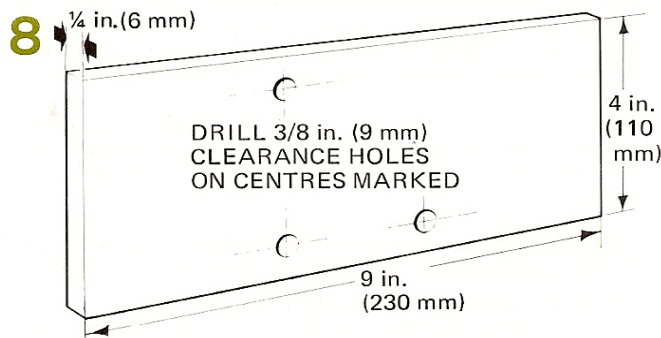
A support plate is required (Fig. 8) to dismantle and re-assemble the unit. If the unit is held in the vice by one of the body mounting lugs, damage to the lug may occur necessitating a new unit.

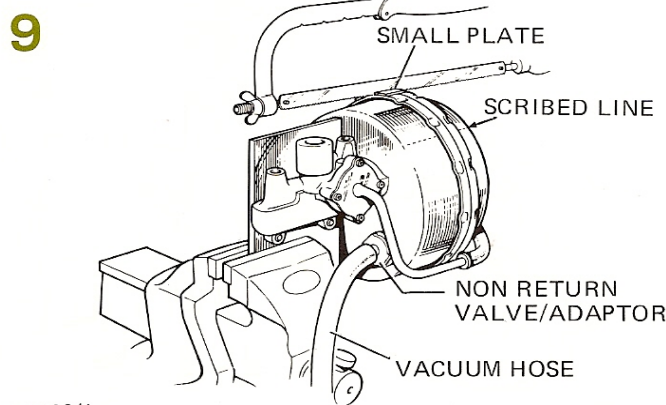
Bolt the support plate to the body and clamp the plate in the vice so that the small plate welded to the clamping ring is uppermost (refer to Fig. 9). On some units the plate may be in a diametrically opposed position on the clamping ring and the unit would therefore be in an inverted position to that shown on the illustration. Before commencing to dismantle the unit, scribe a line across the two halves of the shell adjacent to the small plate, thus enabling the shells to be re-assembled in the same relative positions.

gether. Cover or blank off the hydraulic ports to prevent the entry of filings and saw through the centre of the plate (Fig. 9) taking care not to damage the shells.

leading on the diaphragm plate. Re-position the unit in the vice in the manner shown on (Fig. 9) and place the new retaining band, with bolt and nut, loosely in position on the rear shell. Refit the vacuum hose to the non-return valve/adaptor. Fit the gasket and vacuum pipe to the valve chest and secure with the four setscrews and washers.

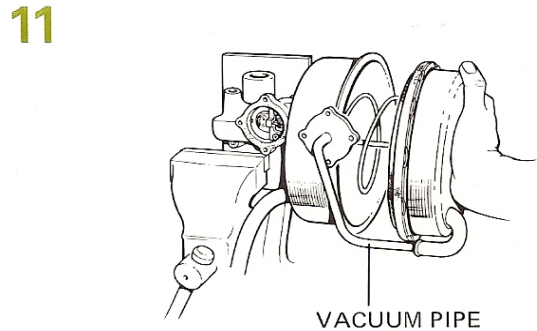
Lever the clamping ring from the shell with a screwdriver (Fig.10) and remove. To allow air to enter the unit and break the vacuum lock, loosen and remove the setscrews securing the valve chest cover. It is important to press firmly with the body against the front shell whilst using the hands to remove the setscrews with a Phillips screwdriver, otherwise the diaphragm return spring may cause the two shells to fly apart. Remove the front shell and spring (Fig. 11). Switch off the engine and remove the vacuum hose from the non-return valve/adaptor. Pull the vacuum pipe from the rubber sleeve. Lever the sleeve from the front shell with a flat screwdriver (Fig. 12), but first remove the support plug from the sleeve by inserting a Phillips screwdriver down the centre and levering it out.

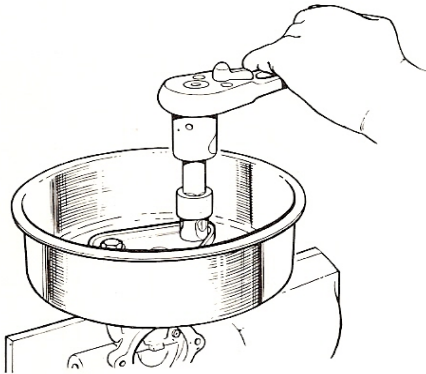
13

Re-position the unit in vice (Fig. 13) and unscrew the three bolts retaining the rear shell to the body. Remove the clamping plate with care as the output piston spring may eject the parts from the bore. If the parts are not ejected, withdraw the bush and hook out the piston rod gland seal when the output piston spring will then eject the anti-knock output piston, piston sleeve spring and ball; but provided care is used these parts will be caught in the rear shell..

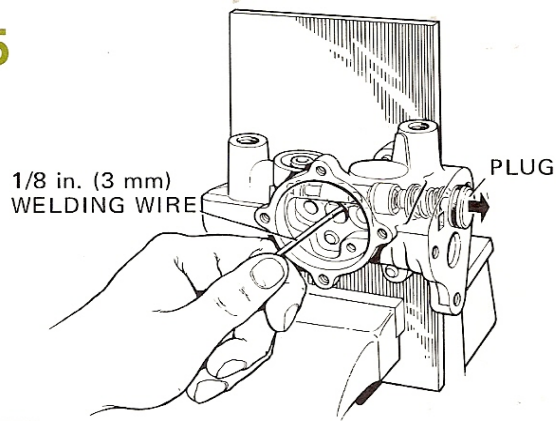
15

Insert a suitable bent rod into the hole in the control piston and lever the piston along to push out the plug (Fig. 15). Remove the control piston from the bore and compress the spring to remove the circlip, retainer and spring abutment. Remove the seals from the plug and control piston.

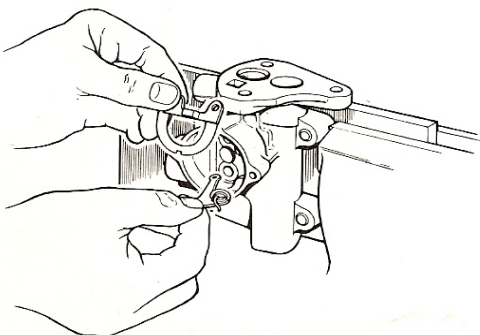
Unscrew the setscrews and remove the lever guide and spring plate from the valve chest (Fig. 14). Before the 'T' lever valve

Position the body in the vice as shown on Fig. 14 and lubricate the output piston bore and seal with clean, unused Castrol-Girling Brake Fluid. Fit the seal to the anti-knock piston so that the seal lips face the reduced end of the piston. Refer to Fig. 17 and with the rear shell in position on the body, fit the anti-knock piston and associated parts into the bore. Care must be taken to ensure the ball remains in the piston and does not drop down the bore. Until the clamping plate is fitted, the parts must be retained in the bore by hand pressure (Fig. 18). Position the plate and secure with bolts and washers. Remove the unit from the vice.

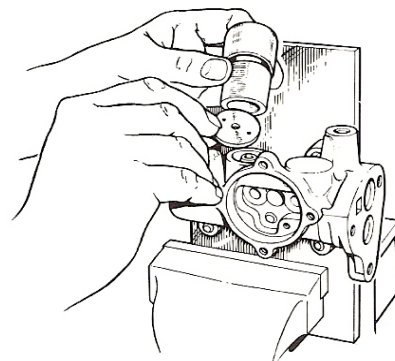
16

Unscrew the setscrew and remove the air filter and associated parts (Fig. 16).

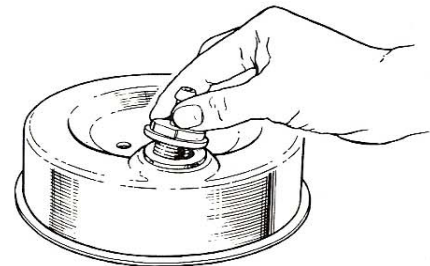
19

Fit the non-return valve/adaptor grommet (Fig. 19) to the rear shell. Lubricate the ribs of the non-return valve/adaptor with Girling Grease No. 64949009 and push fully home in the grommet.

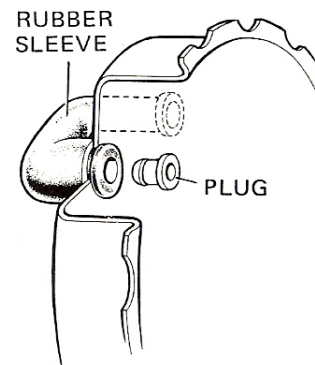
20

Fit the rubber sleeve to the front shell (Fig. 20) lubricate the plug with Girling Grease No. 64949009 and insert as shown.
