VOLVO
KA 47207

A							REPAIR PARTS, BODY SIDE		REPARATIONSDELAR, KAROSSIDA		Group Grupp
B											81
C											Page Sida
D											809
E							4DRS				
Fig	Part No. Artikel nr	Quantity / Antal					P S	Description	Benämning	Notes Anmärkning	S R
		A	B	C	D	E					
1	1315138-6	1	-	-	-	-		Body side, l.h.	Karossida, v		5
	1315139-4	1	-	-	-	-		Body side, r.h.	Karossida, h		5
2	675159-8	1	-	-	-	-		• Cowl side, l.h.	• Torpedsida, v		5
	675160-6	1	-	-	-	-		• Cowl side, r.h.	• Torpedsida, h		5
3	675157-2	1	-	-	-	-		• Cant rail, l.h.	• Taksvällare, v		4
	675158-0	1	-	-	-	-		• Cant rail, r.h.	• Taksvällare, h		4
4	675167-1	1	-	-	-	-		• Window frame, l.h.	• Fönsterram, v		4
	675168-9	1	-	-	-	-		• Window frame, r.h.	• Fönsterram, h		4
5	675163-0	1	-	-	-	-		• Wheel housing, l.h.	• Hjulhus, v		5
	675164-8	1	-	-	-	-		• Wheel housing, r.h.	• Hjulhus, h		5
6	675161-4	1	-	-	-	-		• B-pillar, l.h. inner	• B-stolpe, v inre		3
	675162-2	1	-	-	-	-		• B-pillar, r.h. inner	• B-stolpe, h inre		3

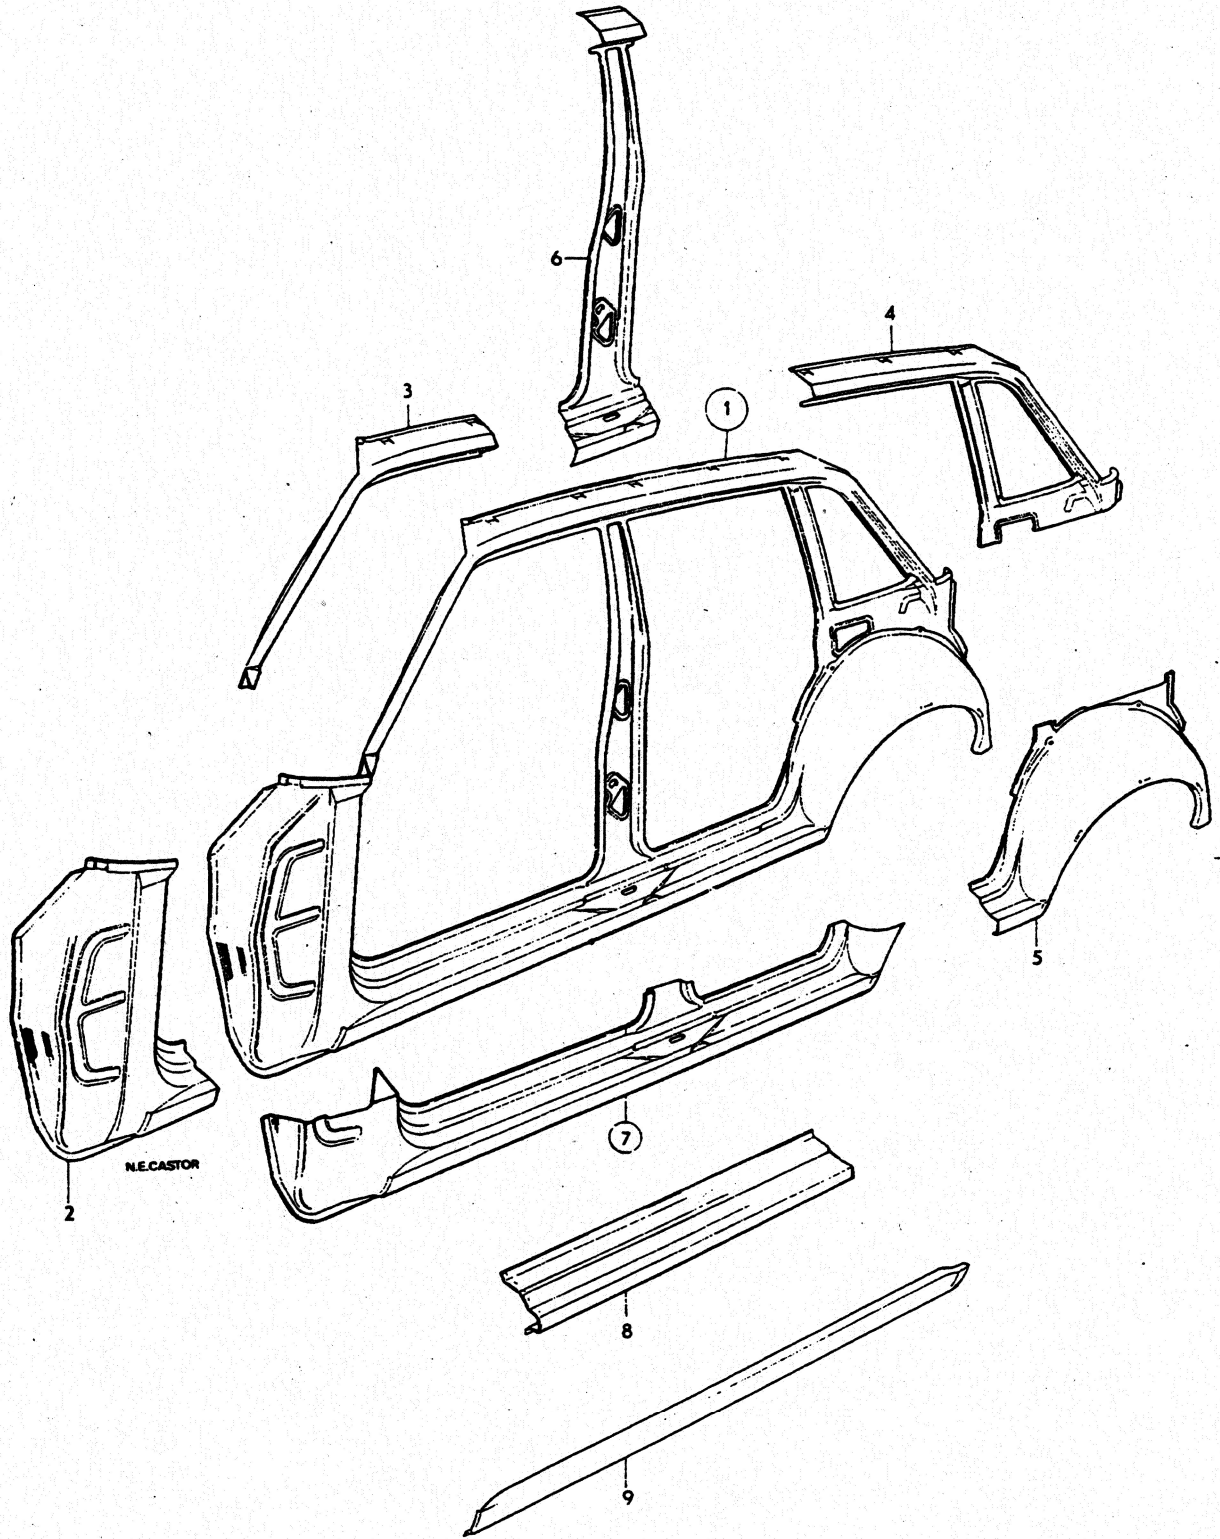
7	675165-5	1	-	-	-	-		• Bottom rail, l.h.	• Bottensvällare, v		3
	675166-3	1	-	-	-	-		• Bottom rail, r.h.	• Bottensvällare, h		3
8	679642-9	2	-	-	-	-		•• Bottom rail	•• Bottensvällare		3
9	679652-8	1	-	-	-	-		•• Bottom rail, l.h. lower part .	•• Bottensvällare, v undre del .		3
	679653-6	1	-	-	-	-		•• Bottom rail, r.h. lower part	•• Bottensvällare, h undre del .		3
