**VOLVO**  
Genuine Parts  
PV 270 43123

| A | | | | | | KONSTANTFARTHÅLLARE | | TEMPOMAT | | Grupp<br>Gruppe | |
| E | | | | | | | | B280E, B280F | | | |

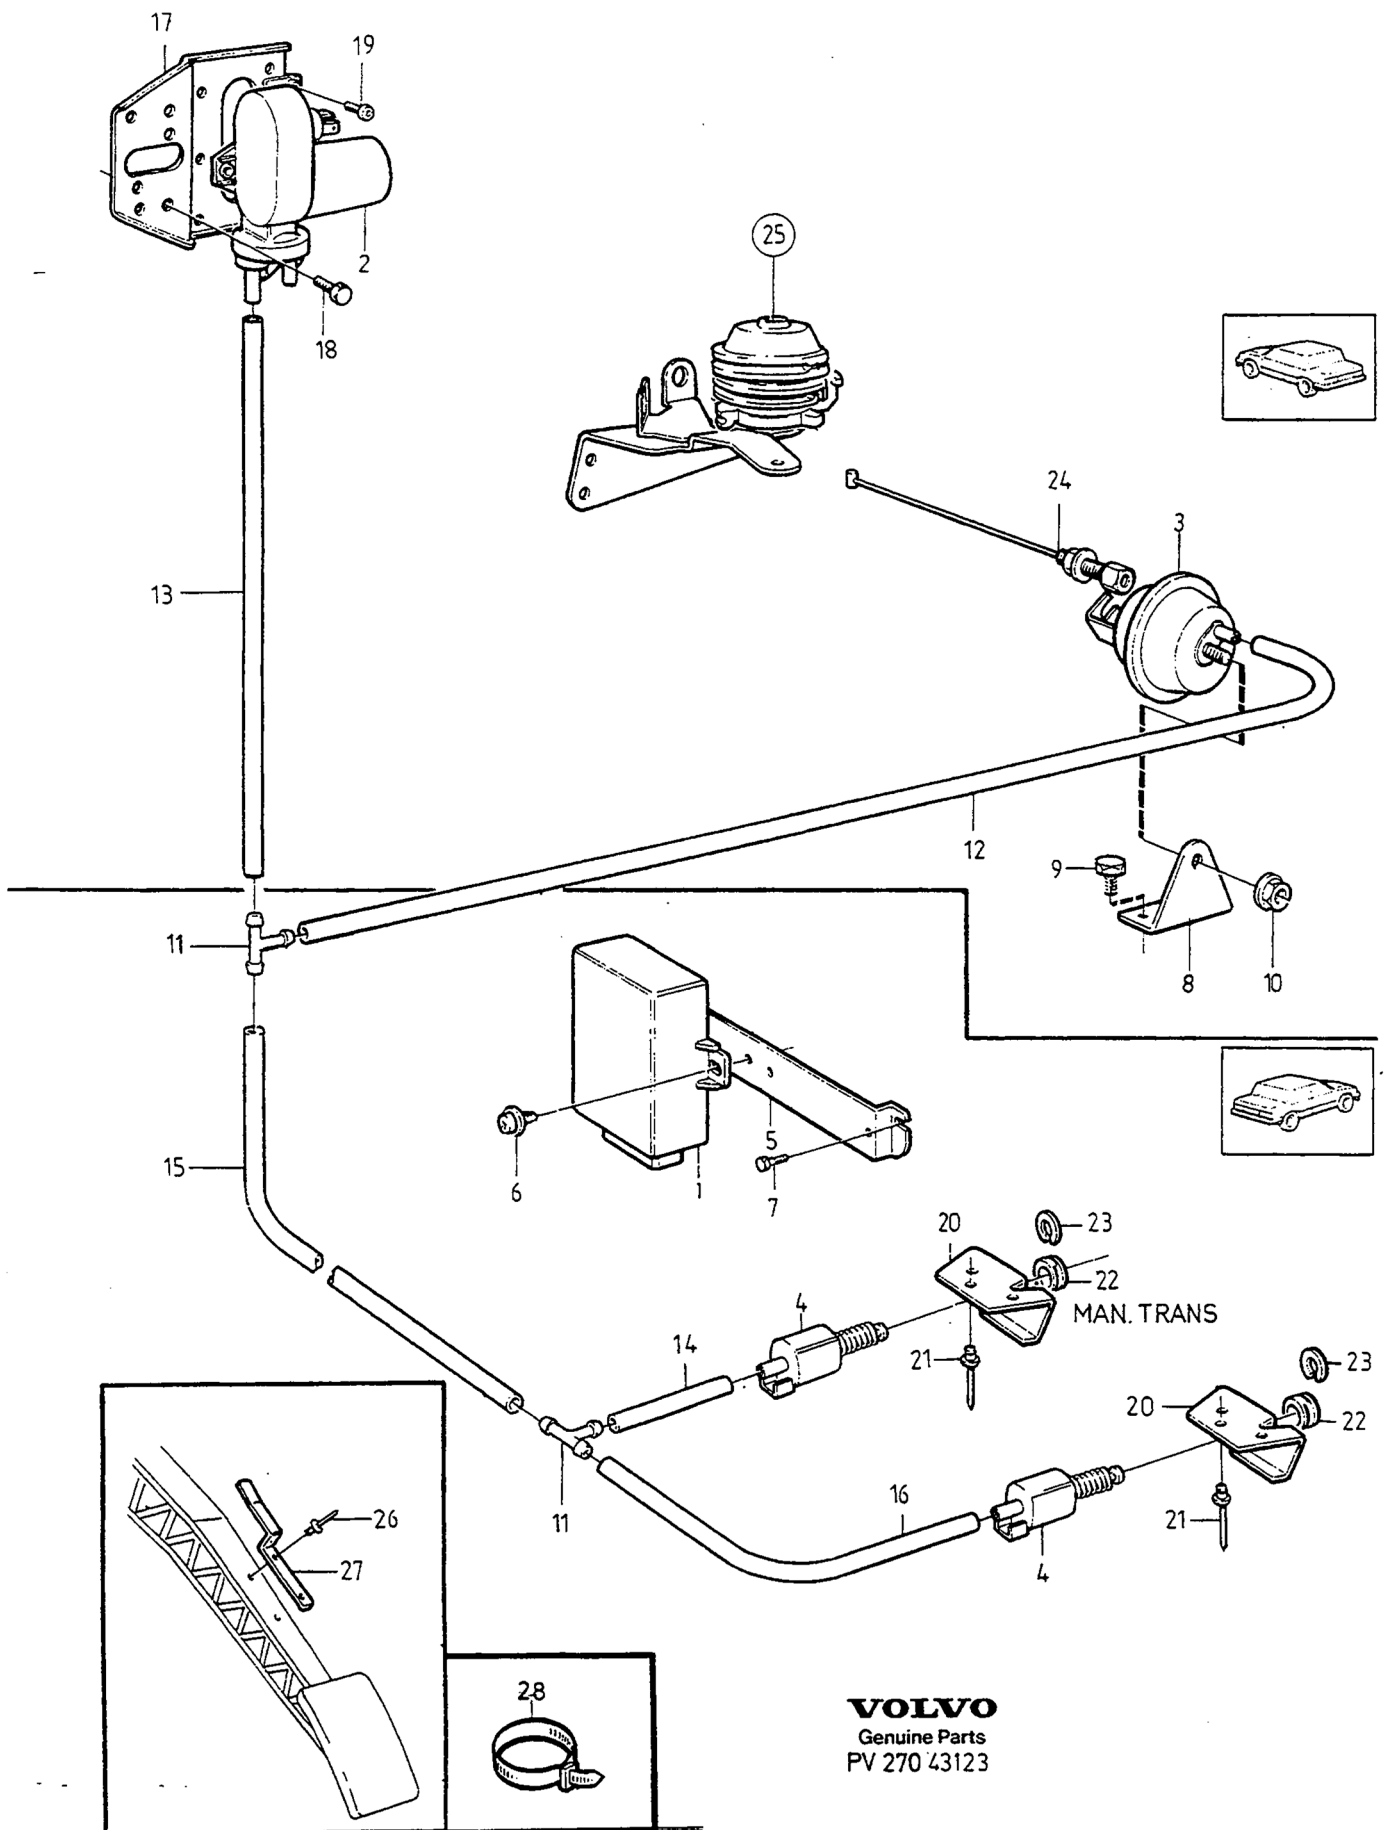
| A | | | | | | KONSTANTFARTHÅLLARE | | TEMPOMAT | | Grupp<br>Gruppe | |
|---|---|---|---|---|---|---|---|---|---|---|---|
| 1 | 3501472-9 | 1 | - | - | - | - | | Styrenhet ..... | Steuergerät ..... | (1273225) | 4 |
| 2 | 1273226-9 | 1 | - | - | - | - | | Vakuumpförstärkare ..... | Unterdruckverstärker ..... | | 4 |
| 3 | 1273227-7 | 1 | - | - | - | - | | Servo enhet ..... | Servoaggregat ..... | | 4 |
| 4 | 1367159-9 | 1 | - | - | - | - | | Avluftningsventil ..... | Entlüftungsventil ..... | | 3 |
| 5 | 1332203-7 | 1 | - | - | - | - | | Konsol ..... | Konsole ..... | | 5 |
