VOLVO PARTS  
1 022 34510  
(102:1)

| A | B23ET | | | | | LADDLUFTKYLNING | | LADELUFTKÜHLUNG | | Grupp<br>Gruppe | |

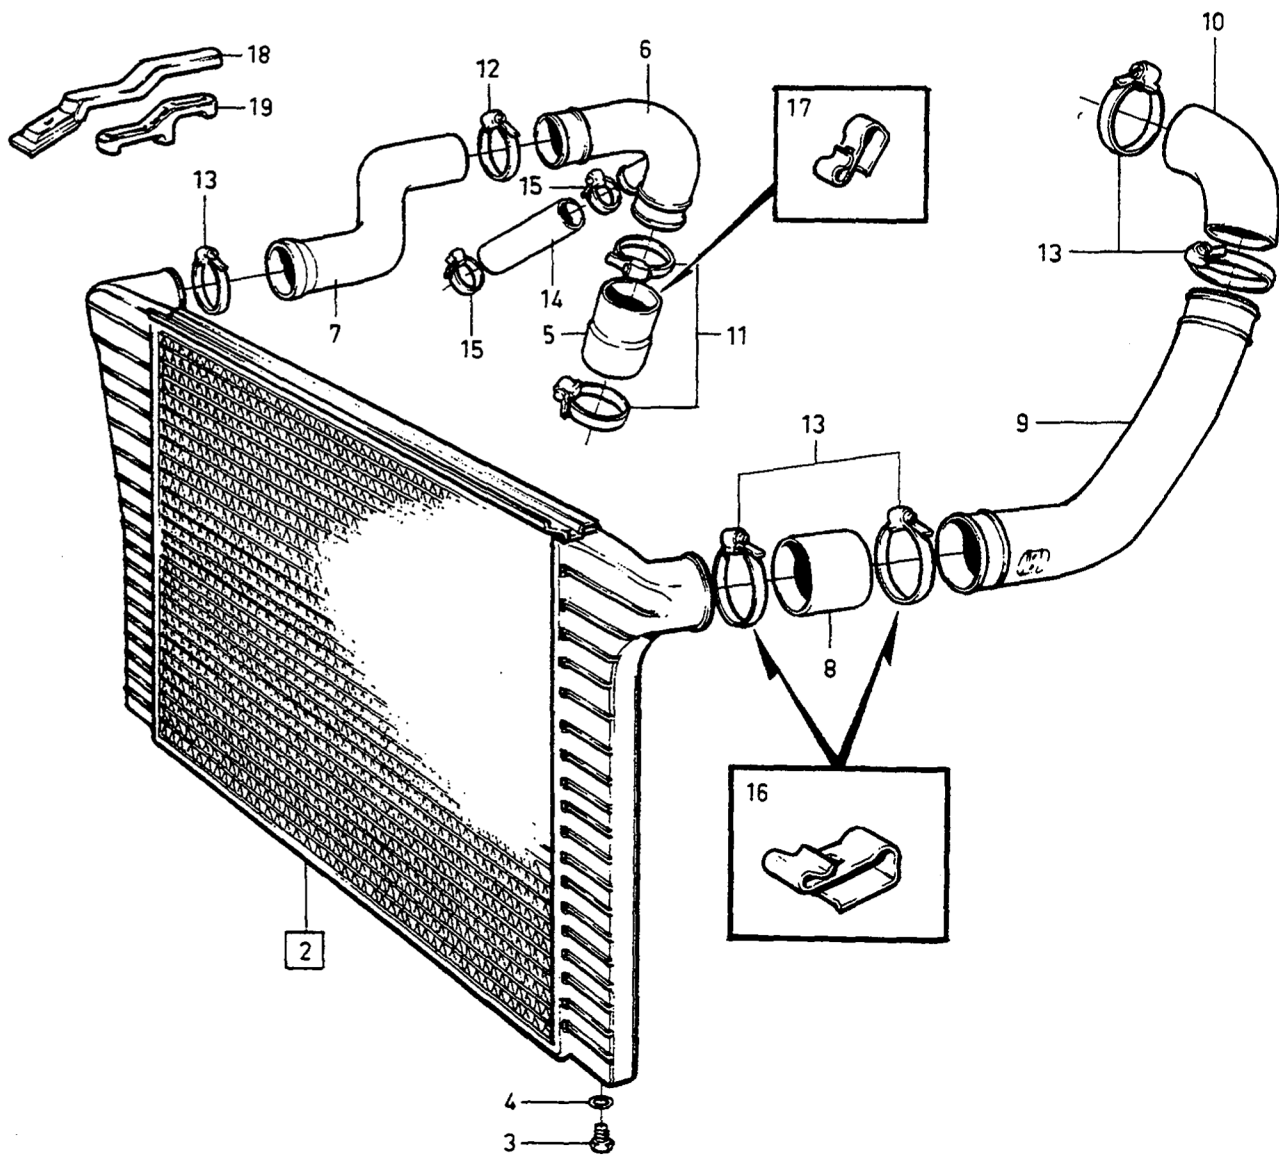
| A | B23ET | | | | | LADDLUFTKYLNING | | LADELUFTKÜHLUNG | | Grupp<br>Gruppe | |
|---|---|---|---|---|---|---|---|---|---|---|---|
| | | | | | | | | B2 3 ET, B2 3 FT | | | |
| Pos | Artikelnummer<br>Artikelnr. | Antal / Anzahl | | | | | P<br>S | Benämning | Bezeichnung | Anmärkning<br>Anmerkung | S<br>R |
| 1 | | 1 | - | - | - | - | NS | Laddluftkylning ..... | Ladeluftkühlung ..... | | |
| 2 | 1317319-0 | 1 | 1 | - | - | - | | • Laddluftkylare ..... | • Ladeluftkühler ..... | | 3 |
| 5 | 1276963-4 | 1 | 1 | - | - | - | | • Slang ..... | • Schlauch ..... | | 3 |
| 6 | 1336438-5 | 1 | 1 | - | - | - | | • Rör ..... | • Rohrleitung ..... | | 3 |
