VOLVO PARTS  
1 080 29016  
(107:6)

| A<br>B<br>C<br>D<br>E | | | | | | | REPAIR PARTS, BODY SIDE | | REPARATIONSDELAR, KAROSSIDA | | Group<br>Grupp |

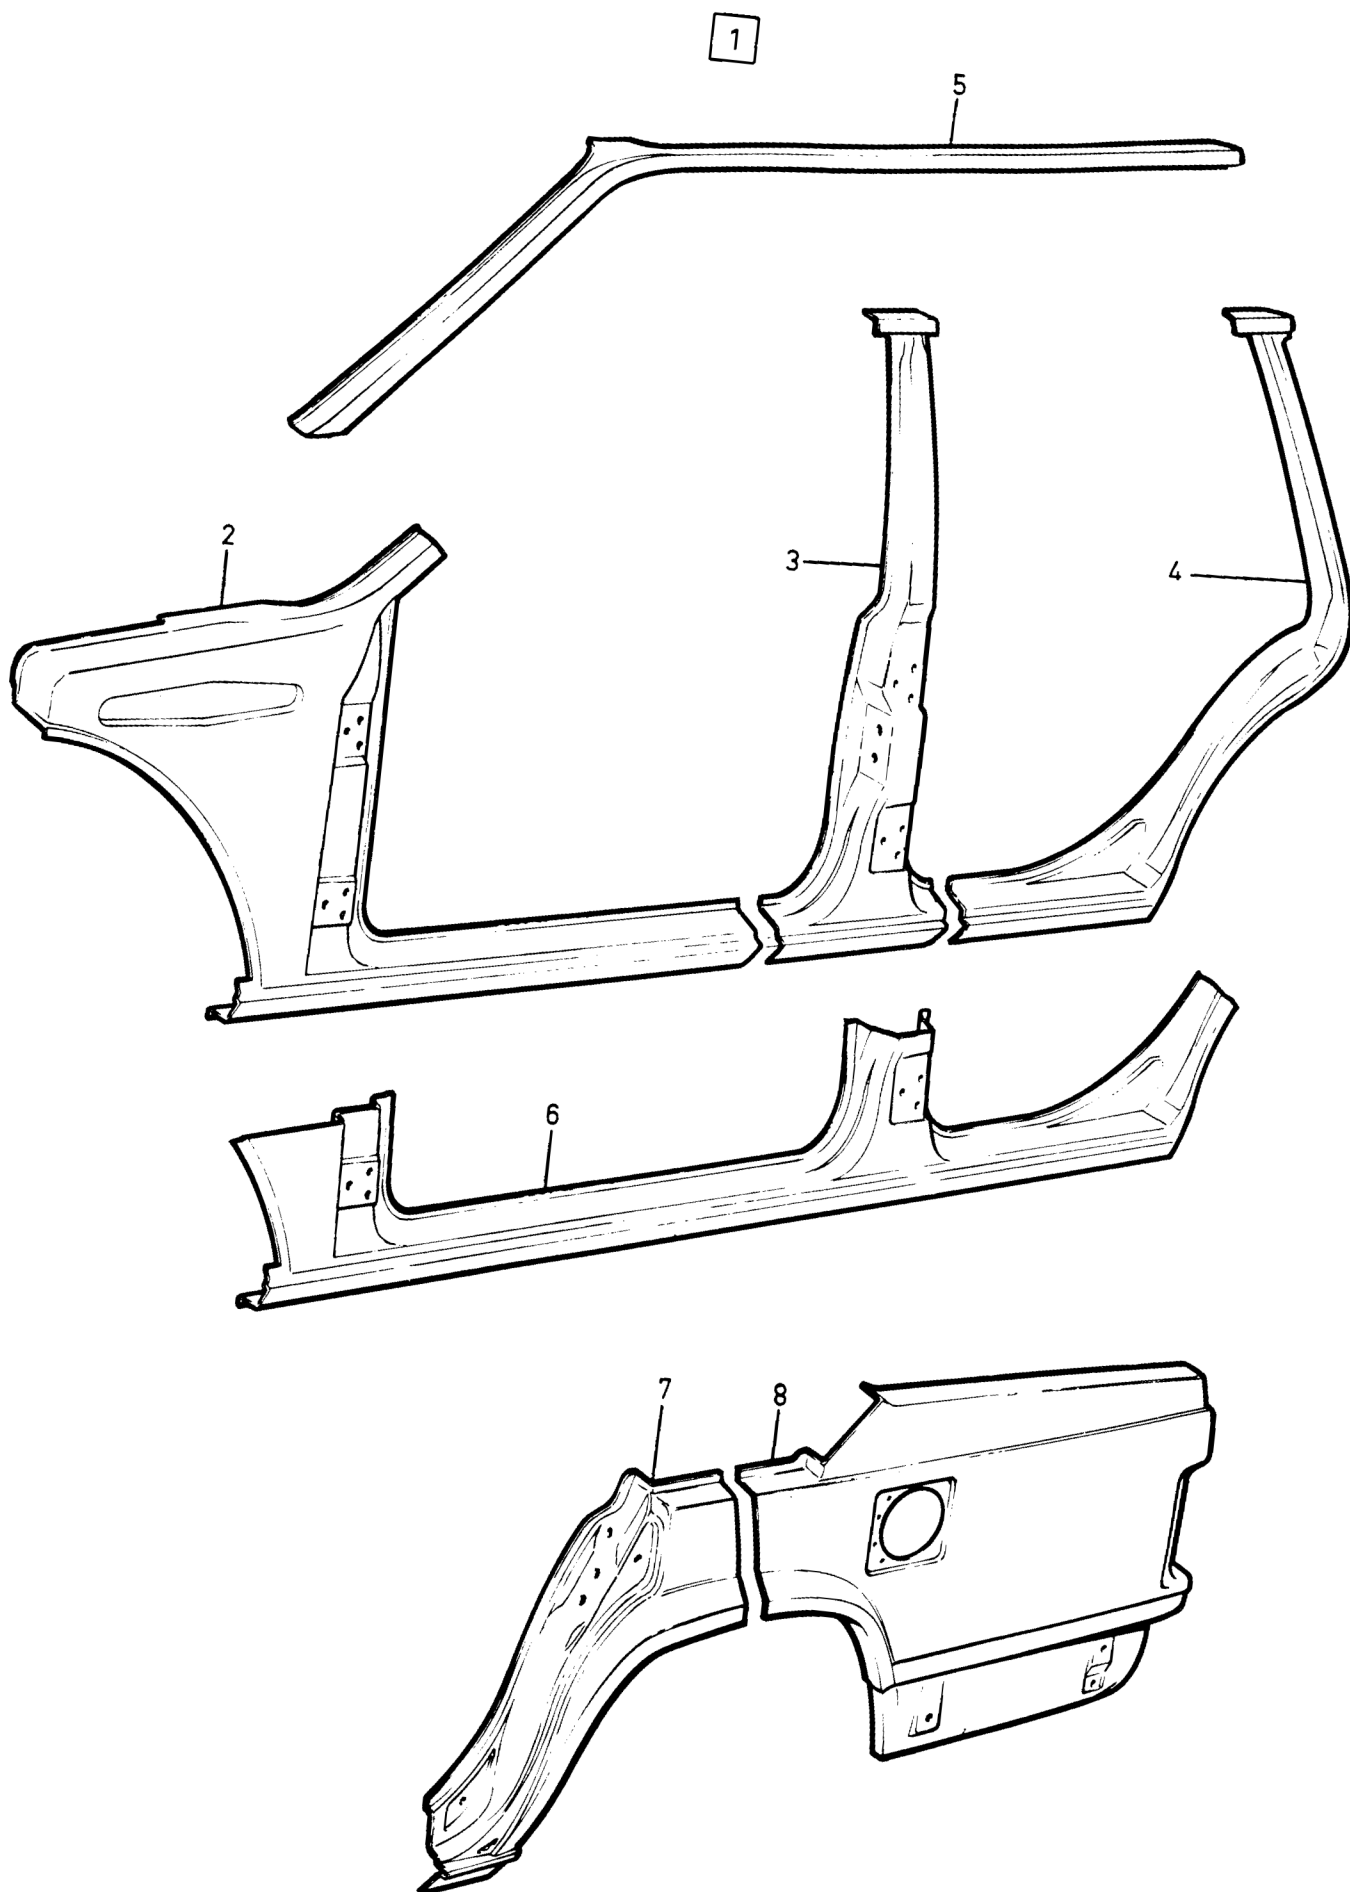
| A<br>B<br>C<br>D<br>E | | | | | | | REPAIR PARTS, BODY SIDE | | REPARATIONSDELAR, KAROSSIDA | | Group<br>Grupp |
|---|---|---|---|---|---|---|---|---|---|---|---|
| ☆ 1 | 3526920-8 | 1 | - | - | - | - | | Body side, l.h. .... | Karossida, v ..... | | 5 |
| ☆ 2 | 3526921-6 | 1 | - | - | - | - | | Body side, r.h. .... | Karossida, h ..... | | 5 |
| 2 | 1380015-6 | 1 | - | - | - | - | | • Cowl side, l.h. .... | • Torpedsida, v ..... | 1) | 5 |
| | 1380016-4 | 1 | - | - | - | - | | • Cowl side, r.h. .... | • Torpedsida, h ..... | 1) | 5 |
| 3 | 1380017-2 | 1 | - | - | - | - | | • B-pillar, l.h. .... | • B-stolpe, v ..... | 1) | 3 |
| | 1380018-0 | 1 | - | - | - | - | | • B-pillar, r.h. .... | • B-stolpe, h ..... | 1) | 3 |
| 4 | 1380019-8 | 1 | - | - | - | - | | • Rear pillar, l.h. .... | • Bakstolpe, v ..... | 1) | 4 |
| | 1380020-6 | 1 | - | - | - | - | | • Rear pillar, r.h. .... | • Bakstolpe, h ..... | 1) | 4 |
| 5 | 1380021-4 | 1 | - | - | - | - | | • Cant rail, l.h. .... | • Taksvällare, v ..... | 1) | 4 |
| | 1380022-2 | 1 | - | - | - | - | | • Cant rail, r.h. .... | • Taksvällare, h ..... | 1) | 4 |
| 6 | 1380023-0 | 1 | - | - | - | - | | • Bottom rail, l.h. .... | • Bottensvällare, v ..... | 1) | 3 |
| | 1380024-8 | 1 | - | - | - | - | | • Bottom rail, r.h. .... | • Bottensvällare, h ..... | 1) | 3 |
| 7 | 1355885-3 | 1 | - | - | - | - | | Mudguard repair part, l.h. .... | Skärmdel, v ..... | 1) | 2 |
| | 1355886-1 | 1 | - | - | - | - | | Mudguard repair part, r.h. .... | Skärmdel, h ..... | 1) | 2 |
| 8 | 3526117-1 | 1 | - | - | - | - | | Rear mudguard l.h. .... | Bakskärm v ..... | 1) 4DRS | 2 |
| | 3526118-9 | 1 | - | - | - | - | | Rear mudguard r.h. .... | Bakskärm h ..... | 1) 4DRS | 2 |
